Online Condition Monitoring on a Rotary Calciner

Rick Verbij

SPM Instrument BV

February, 2018

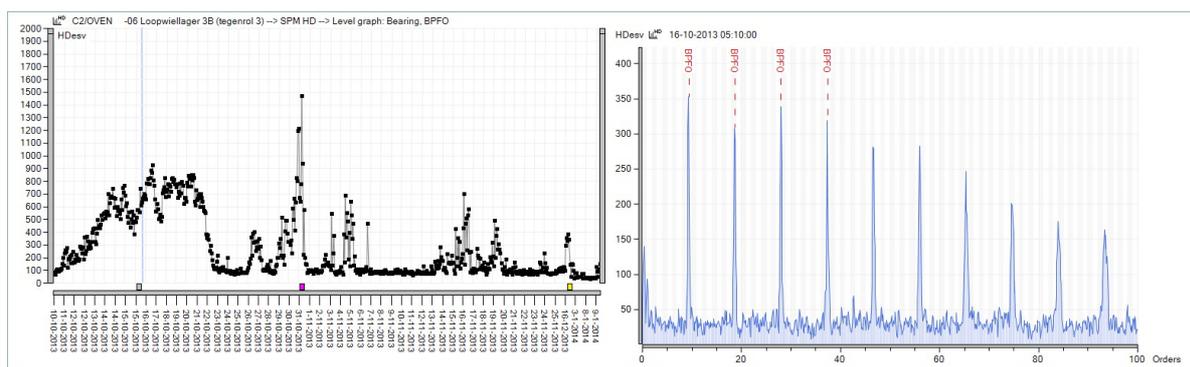
Fig 3. SPM HD trend graph of outer race defect frequency, and a frequency spectrum (FFT) with markers on BPFO.

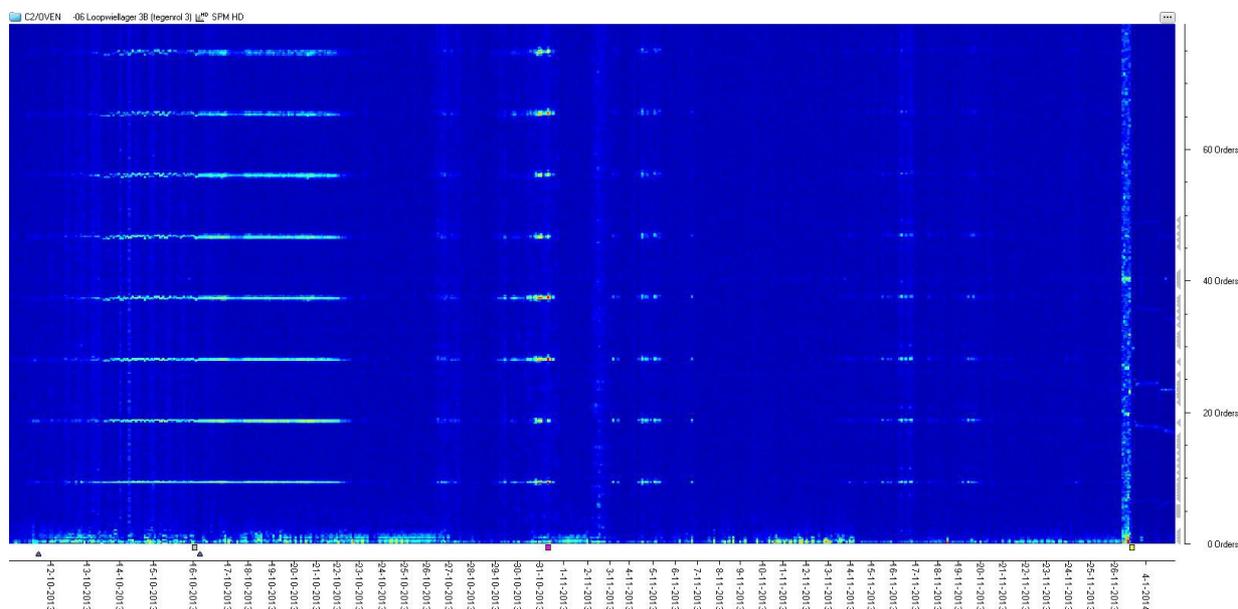
Fig 4. SPM HD Color Spectrum Overview showing increasing amplitude for BPFO, and the spalling process. At the end of October, a short strong increase in BPFO can be noticed.

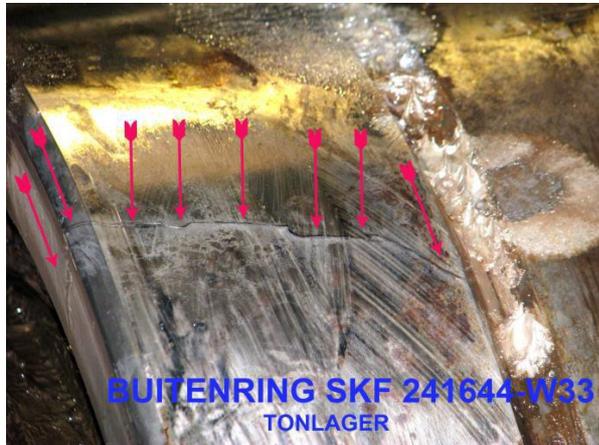
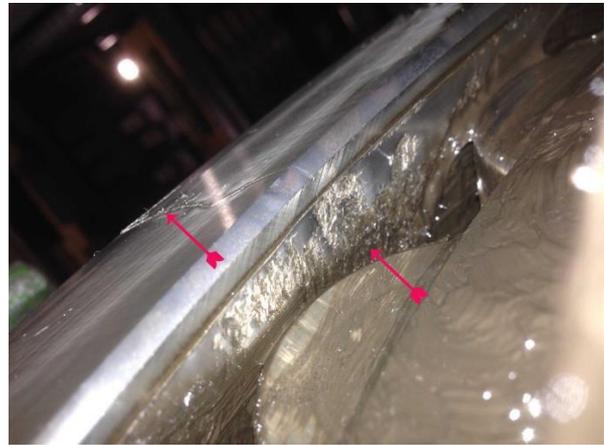
5.1 Case #1: Outer race damage – Bearing 3B with SPM HD

Image 2. Photos of bearing 3B showing the damaged outer race. The bearings were replaced in the beginning of January, 2014.

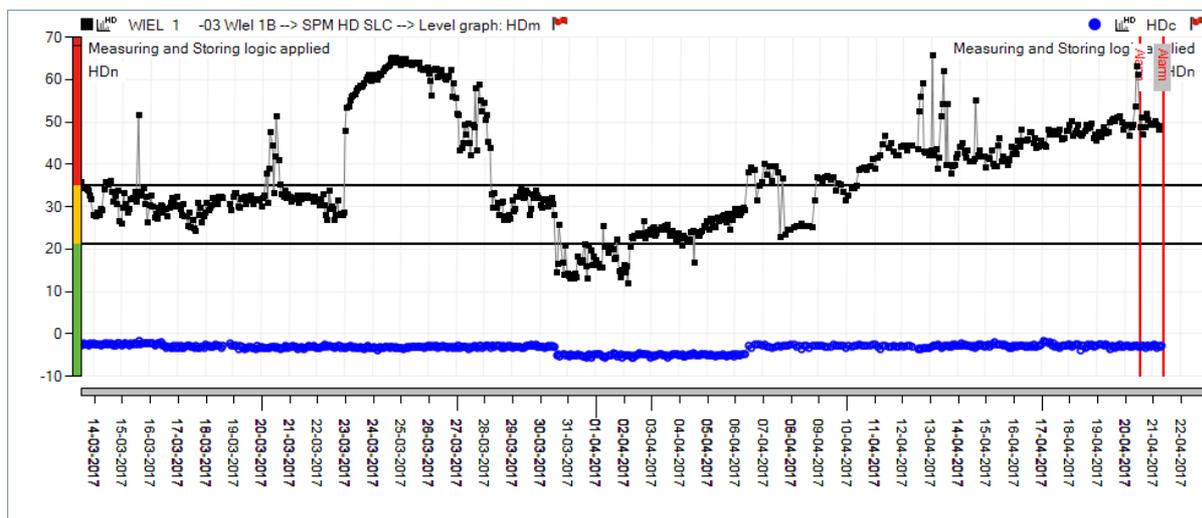
Fig 5. SPM HD measurement with DuoTech starting March 14, 2017. SPM HD measurements taken with 44000 transducers already detected the first signs of outer race defects in June, 2016, providing over ten months pre-warning time.

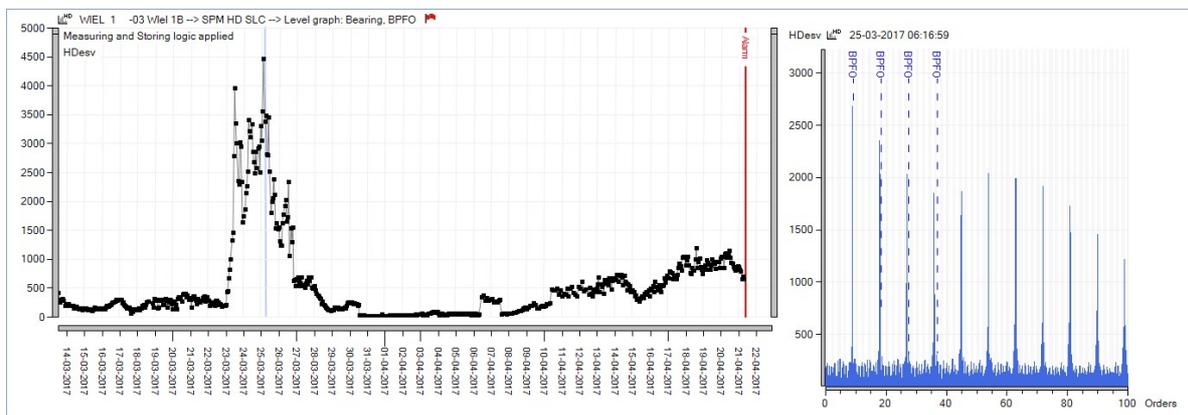
Fig 6. BPFO trend graph and FFT. Notice the low noise floor in the FFT.

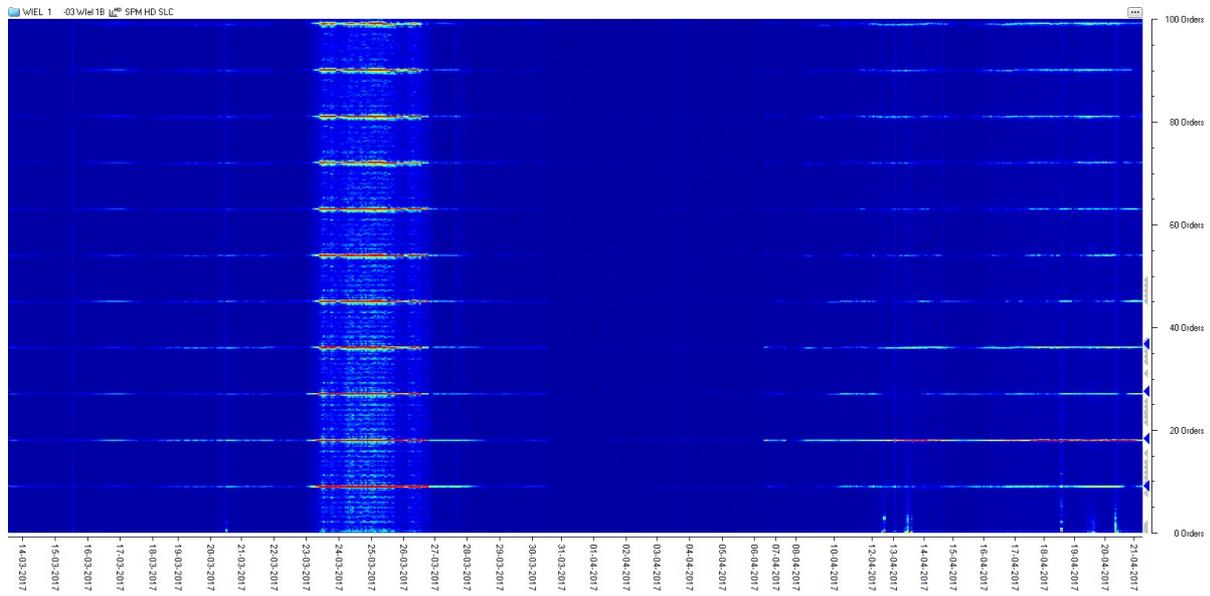
Fig 7. The spalling process is clearly visible in the Color Spectrum Overview.

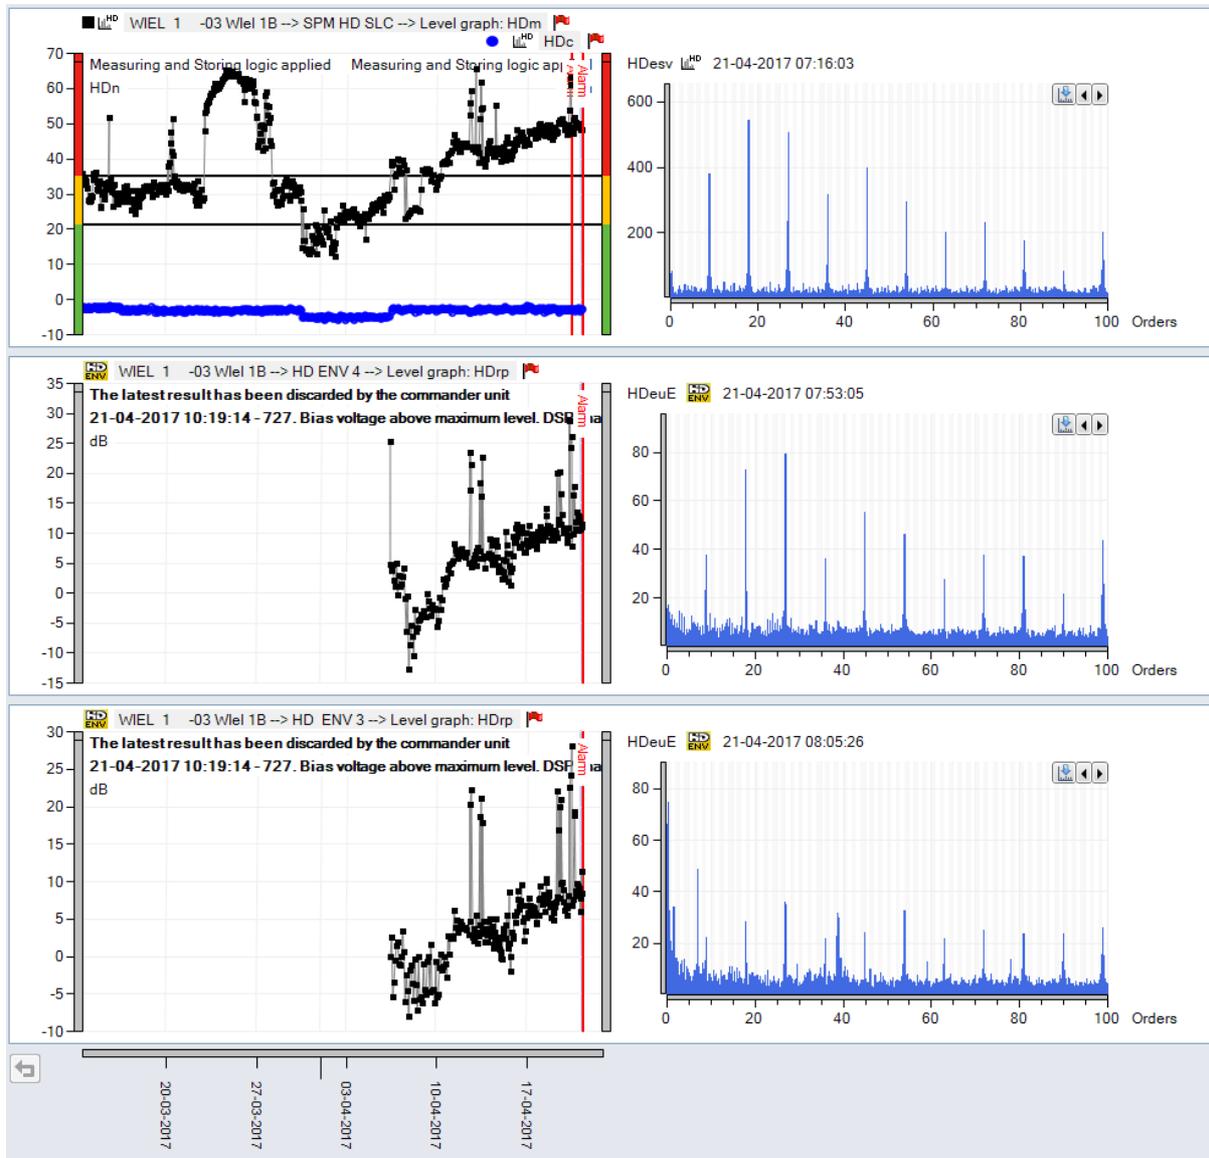
Fig 8. Around April 5, 2017, HD ENV measurements were added, showing clear signs of outer race bearing wear.

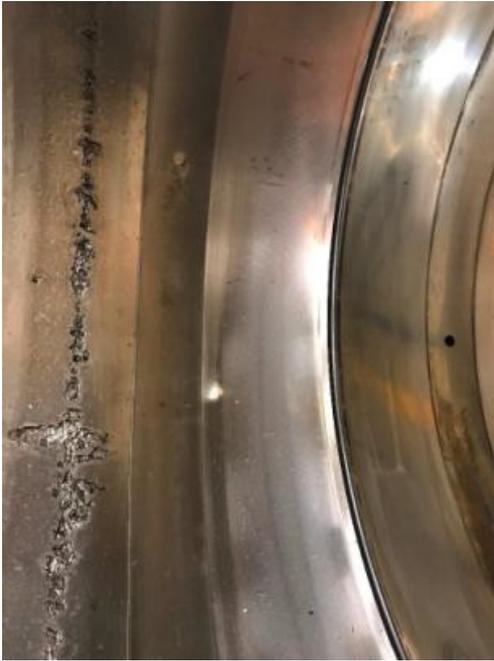
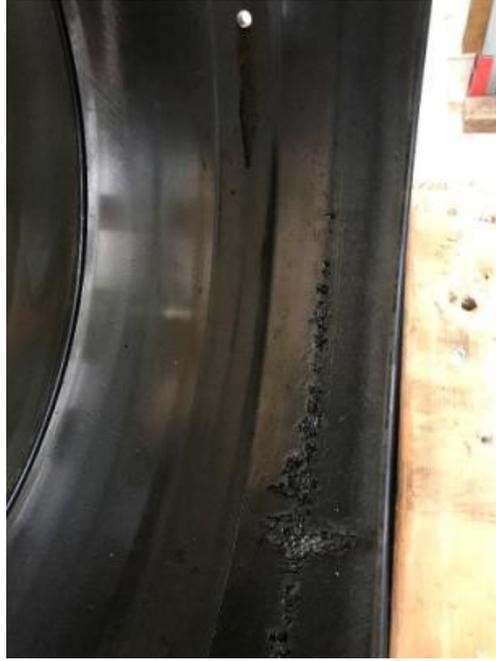
5.2 Case #2: Outer race damage – Bearing 1B with DuoTech/HD ENV

Image 3. Photos of bearing 1B taken after bearing replacement.

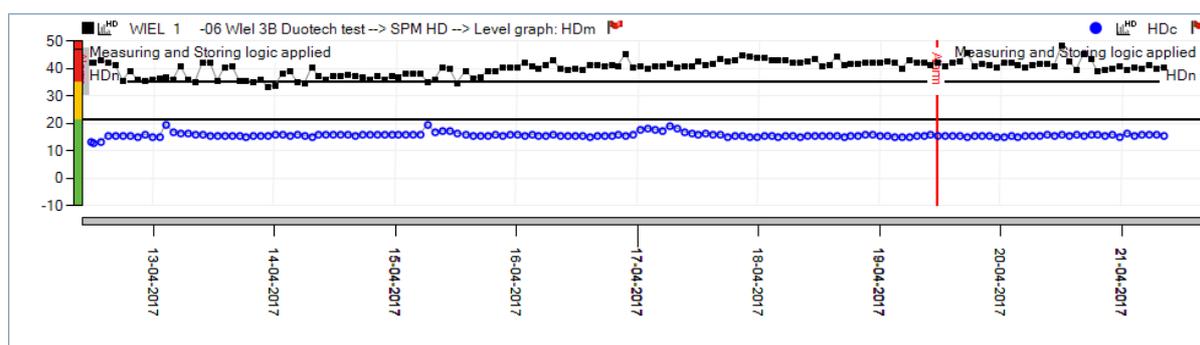
Fig 9. SPM HD measurement with DuoTech, starting on April 12, 2017. SPM HD measurements taken with 44000 transducers already detected the first signs of outer race defects in July, 2016, providing over nine months pre-warning time. In the SPM HD trend graph below, HDm was already elevated due to the presence of an outer race defect. HDc does not show any signs of electrical interference.

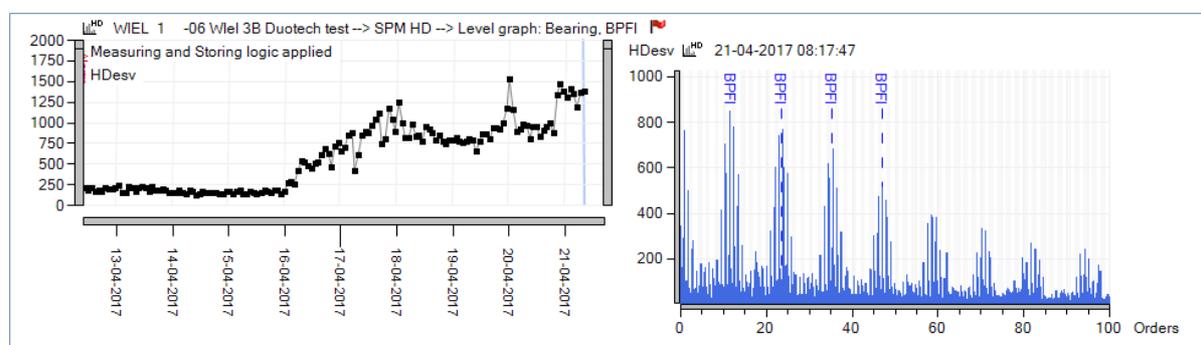
Fig 10. The BPF1 trend graph starts to show increasing levels in mid April. BPF1 is marked in the FFT. Strong sidebands can be observed.

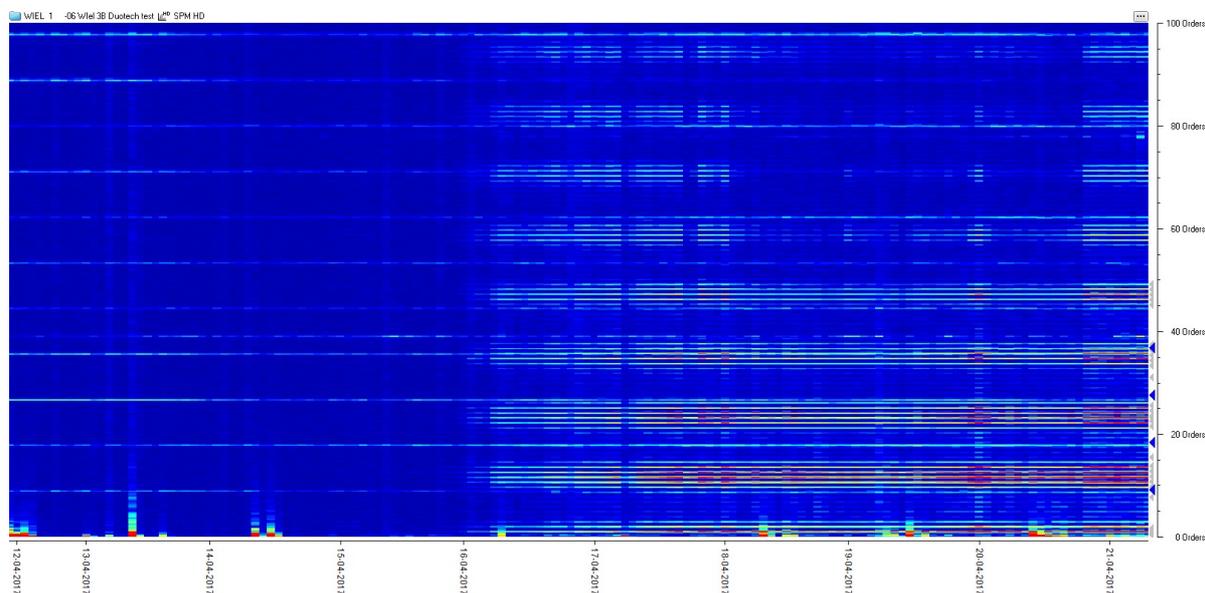
Fig11. The outer race defect is present from the start. The sudden strong increase of the inner race defect frequency, including harmonics and sidebands is clearly visible in the Color Spectrum Overview.

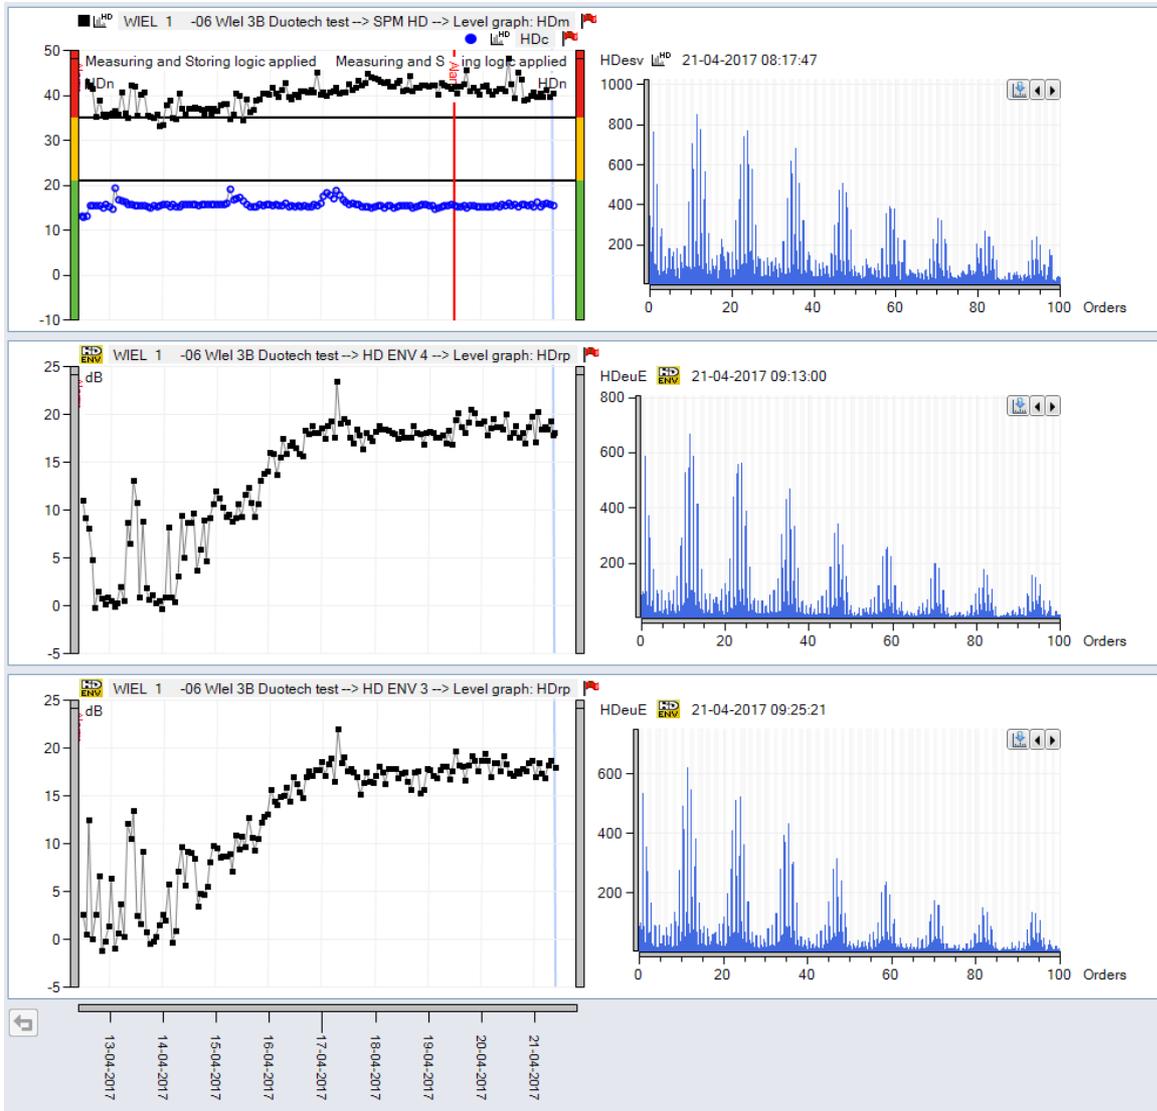
Fig 12. The inner race defect is effectively picked up with HD ENV Filters 4 and 3.

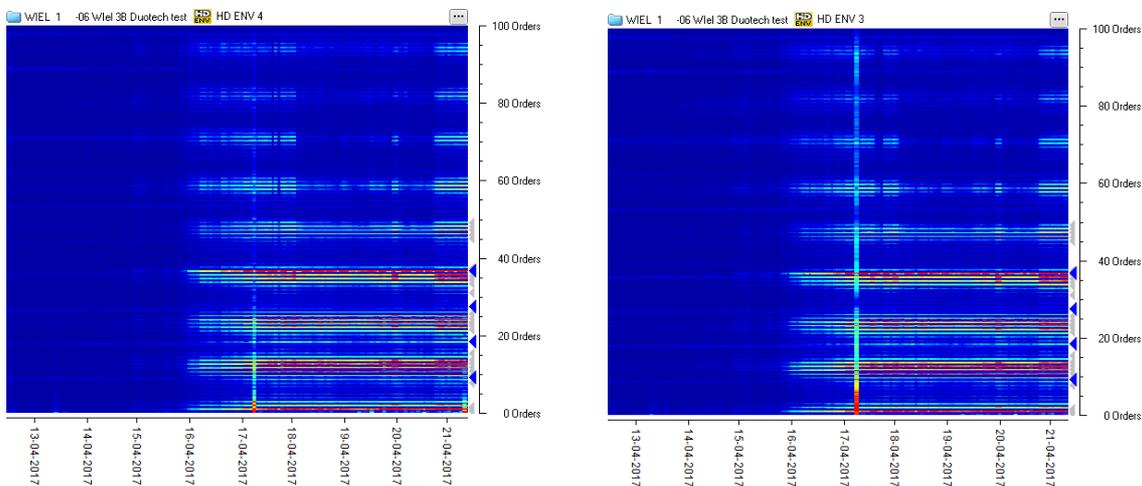
Fig 13. The Color Spectrum Overview looks similar to that of SPM HD. It is very clean, indicating a low noise floor and confirming the ability of DuoTech to be used in environments with strong electrical interference.

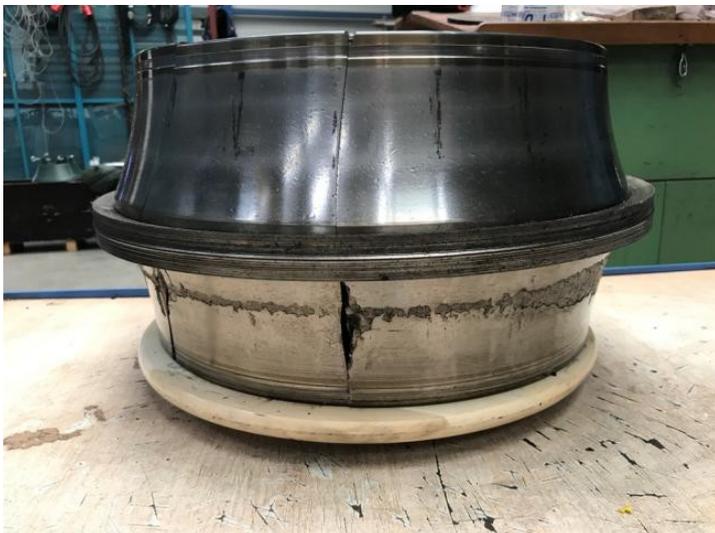
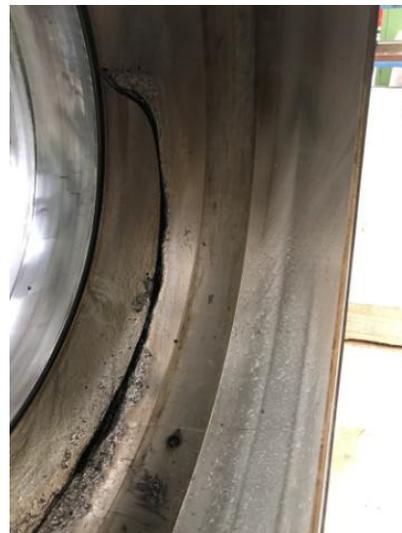
5.3 Case #3: Outer/inner race damage – Bearing 3B with DuoTech/HD ENV

Image 4. Photos showing severe – Stage 4 – inner race and outer race damage.

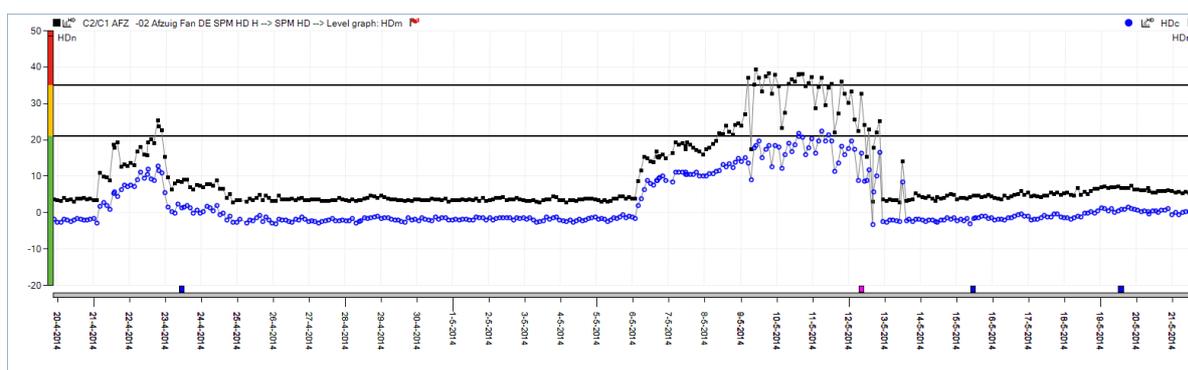
5.4 Case #4: Lack of lubrication in fan bearings

Fig 14. SPM HD measurement showing increasing HDm/HDc levels. The squares at the bottom of the trend graph indicate the dates when the bearing was lubricated.
