# Ball Mill Bearing Damage

Sverre Nergaard

*SPM Instrument AS, Norway*

August, 2017

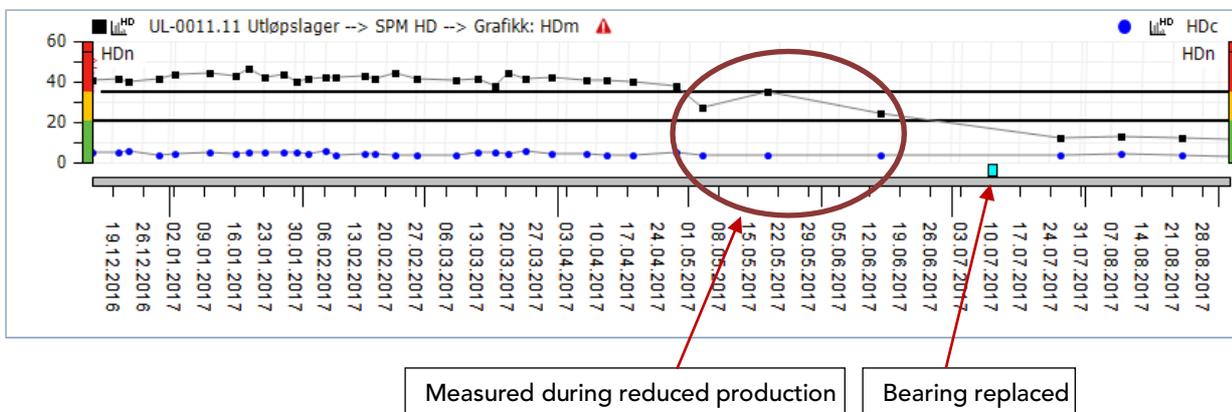
Since mid-December 2016 up until the summer of 2017, the bearing in question had been frequently measured. From the very first measurement result, bearing damage was suspected. There were relatively high SPM HD and HD ENV4 values, and a BPFO match for both measurement techniques.

Over the following months, the measured SPM HD results were relatively high but stable, with no obvious development. The BPFO values, however, showed an increasing trend.

Fig. 1 SPM HD trend.

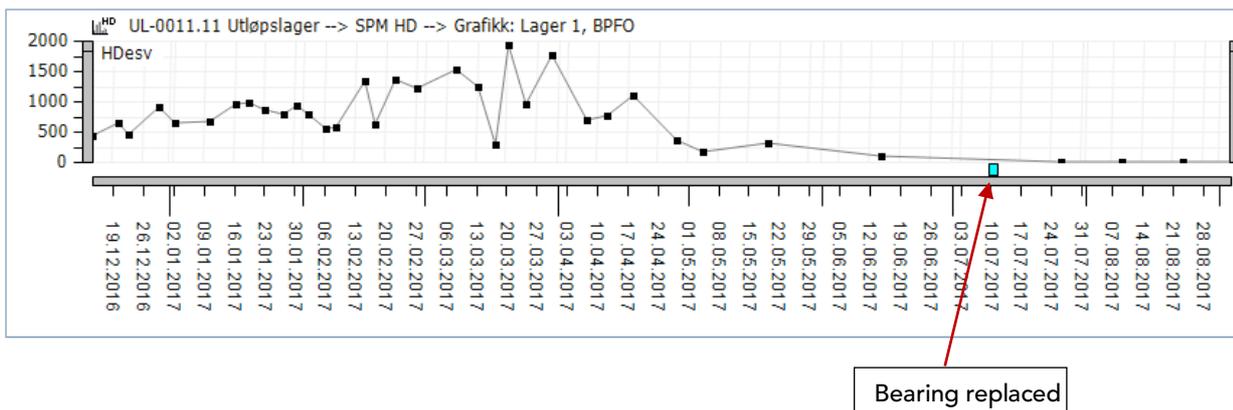
Fig. 2 BPFO trend.

It was decided to replace the bearing during the planned maintenance summer stop, and a new bearing was ordered well in advance (the delivery time for a new bearing of this type is close to three months).

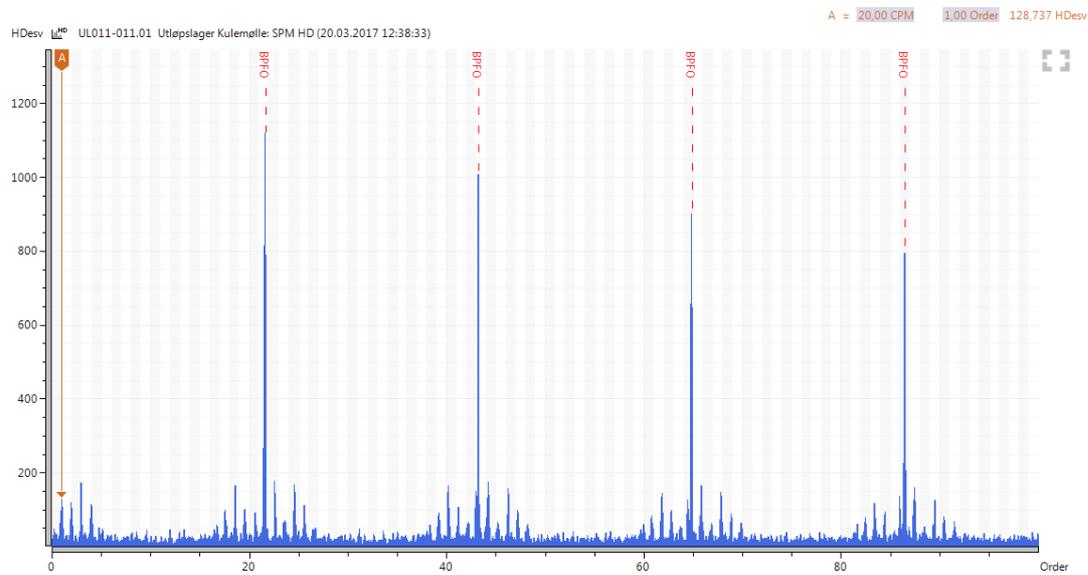
**Fig. 3** Spectrum from before bearing replacement.

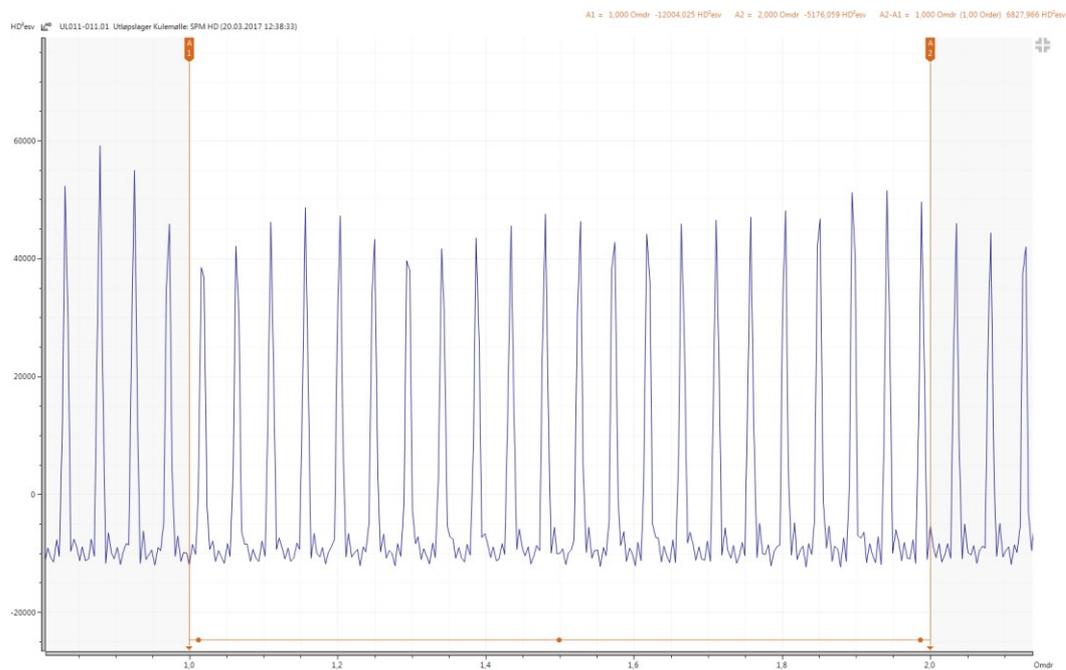
**Fig. 4** Time waveform from before bearing replacement.

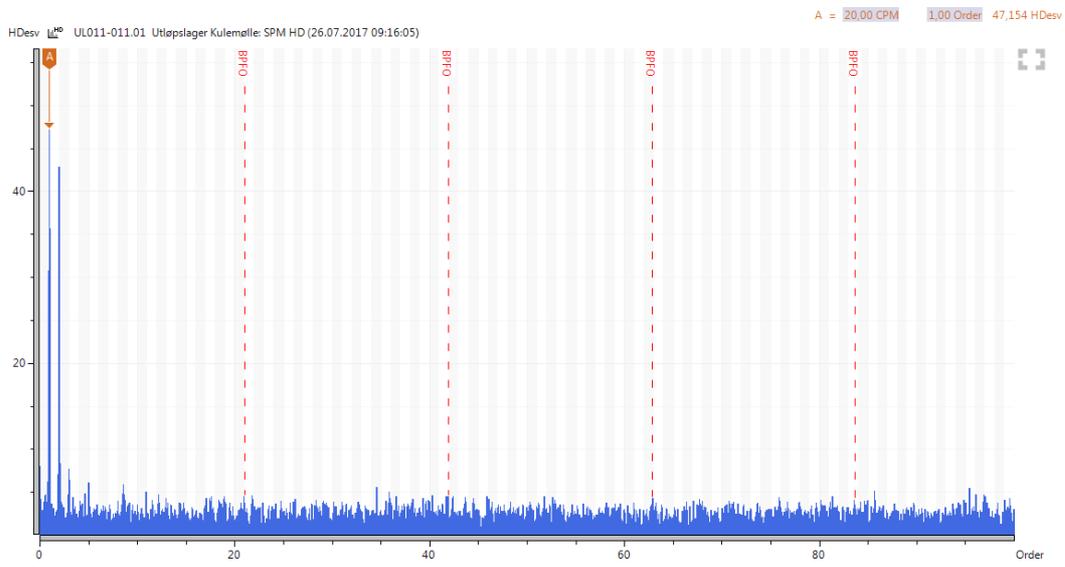
*Fig. 5 Spectrum from after bearing replacement.*

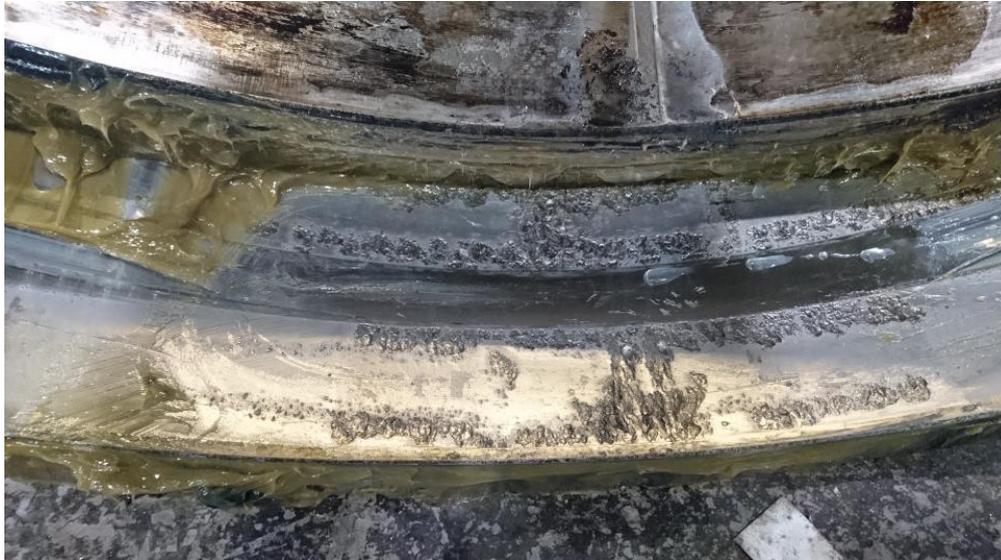
Measuring point: Ball mill Output Main Bearing  
 Bearing type: SKF 239/850  
 Rpm: 20

*Img. 3 Photograph of the outer race damage.*

Thanks to the fact that this bearing damage was detected through measurements, the bearing replacement could be carefully planned to take place during the planned maintenance summer stop.
