Bearing Damage

Pulp Washer

Sverre Nergaard

SPM Instrument AS, Norway

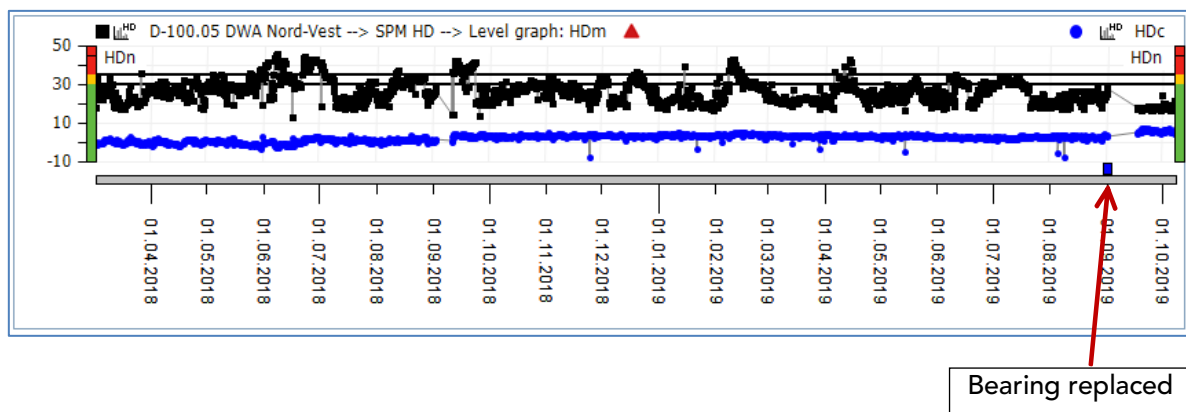
The online monitoring system was put into operation on March 1st, 2018. Two to three months after system startup, there was an indication of developing bearing damage. The bearing condition remained under continuous observation, and during the planned maintenance stop in September 2019, the bearing was replaced. The prewarning time was about eighteen months.

Image 1 SPM HD condition trend.

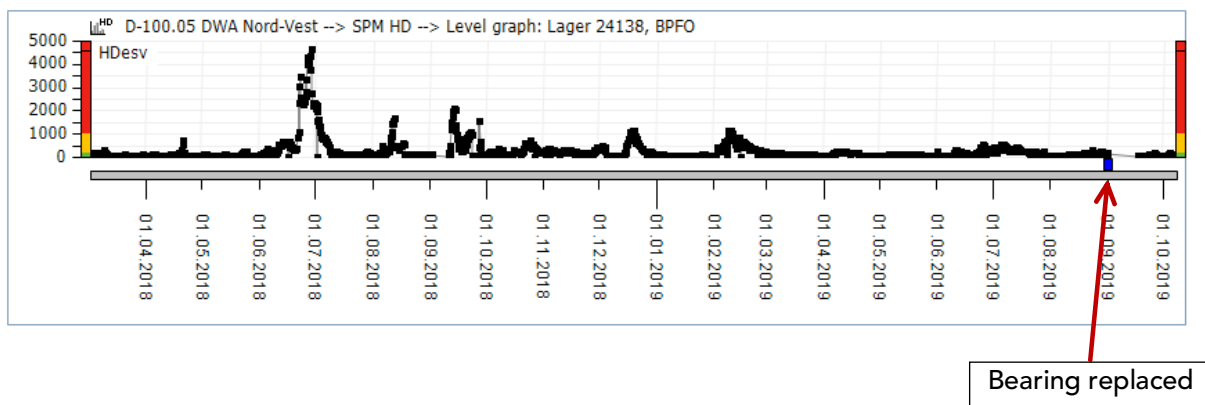
Image 2 Ball pass frequency outer race (BPFO) trend.

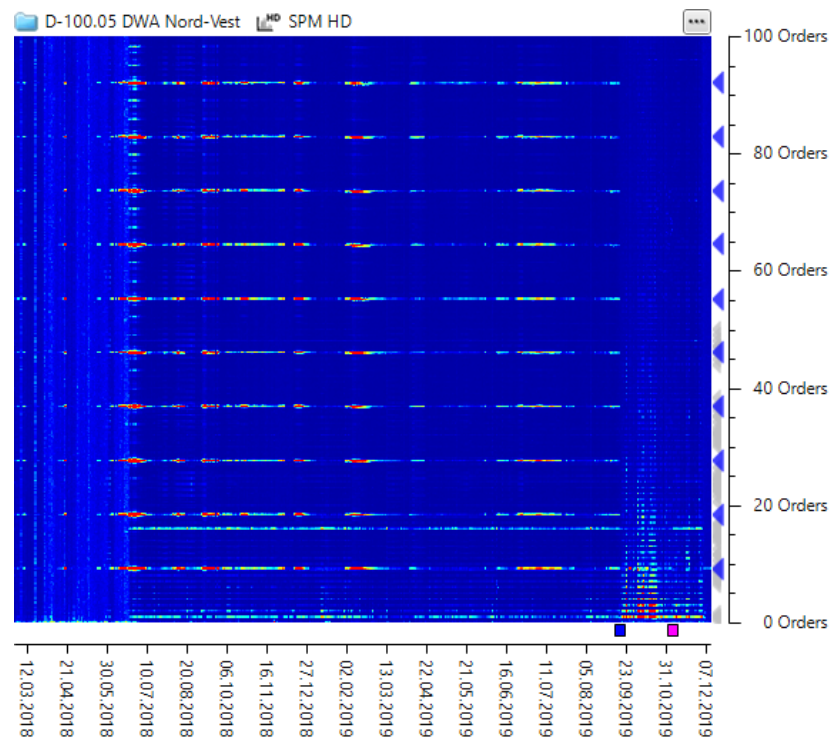
The Colored Spectrum Overview function in the Condmaster software can be used to reveal if a spalling process is going on in the bearing. The pattern seen in Image 3 below is typical of damage development caused by spalling, where long periods with high shock pulse levels, followed by a period of lower levels, are often observed.

Image 3 Colored Spectrum Overview.

Depending on load, RPM, temperature, and other application-related parameters, the periods of increasing values may last for many days or weeks, succeeded sometimes by slowly or abruptly decreasing levels. The slowly decreasing levels are a sign that the sharp edges around a fresh spall are wearing down, while an abruptly decreasing level is a sign of metal parts breaking away from the raceways.

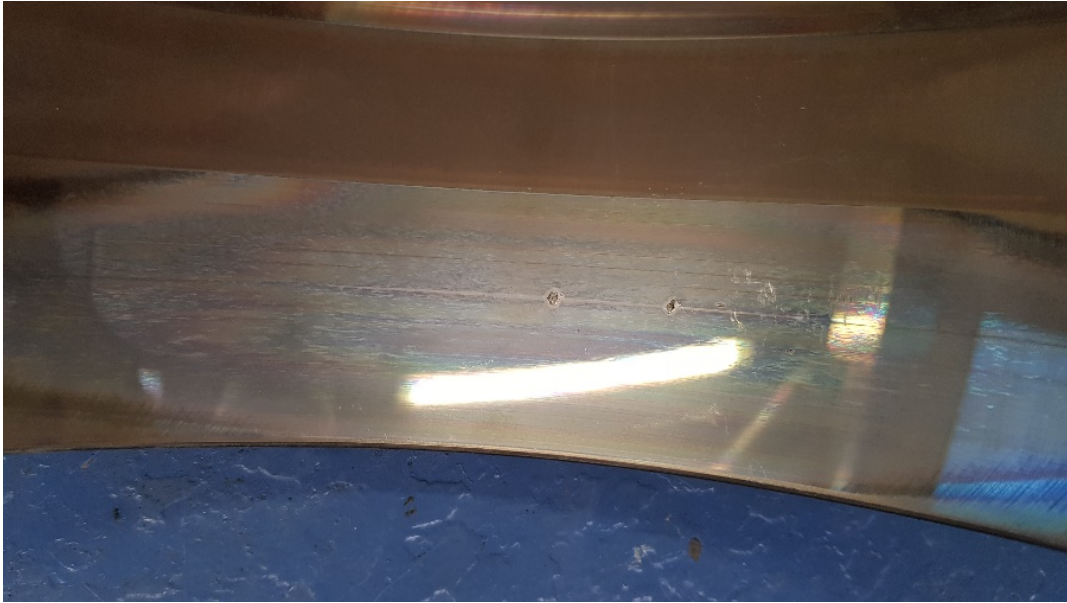
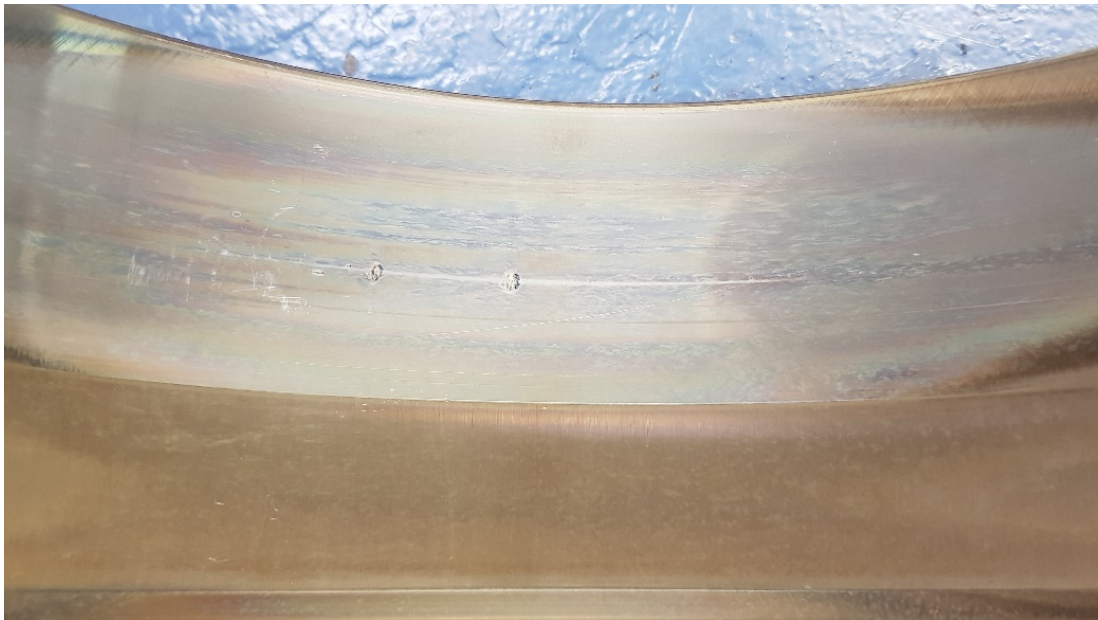
Image 1 Photograph of the outer race damage.

Image 2 Photograph of the outer race damage.
