Online Condition Monitoring on a Rotary Calciner

Rick Verbij

SPM Instrument BV

February, 2018

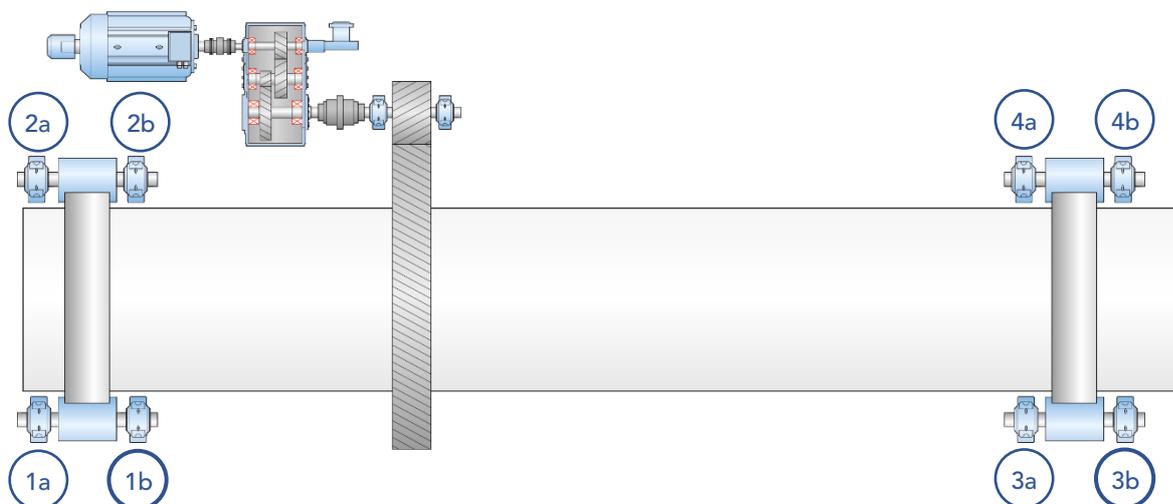
Fig 1. The mechanical construction of the calciner. This case study involves damages detected on bearings 1b and 3b, respectively, and also shows a lubrication problem in the fan bearings.
